# ASSOCIATION OF BUILDING COMPLIANCE

Simon Davis: Fire Engineering Manager

# RAISING THE BAR

COMPLIANCE: THE LAST LINE OF DEFENCE

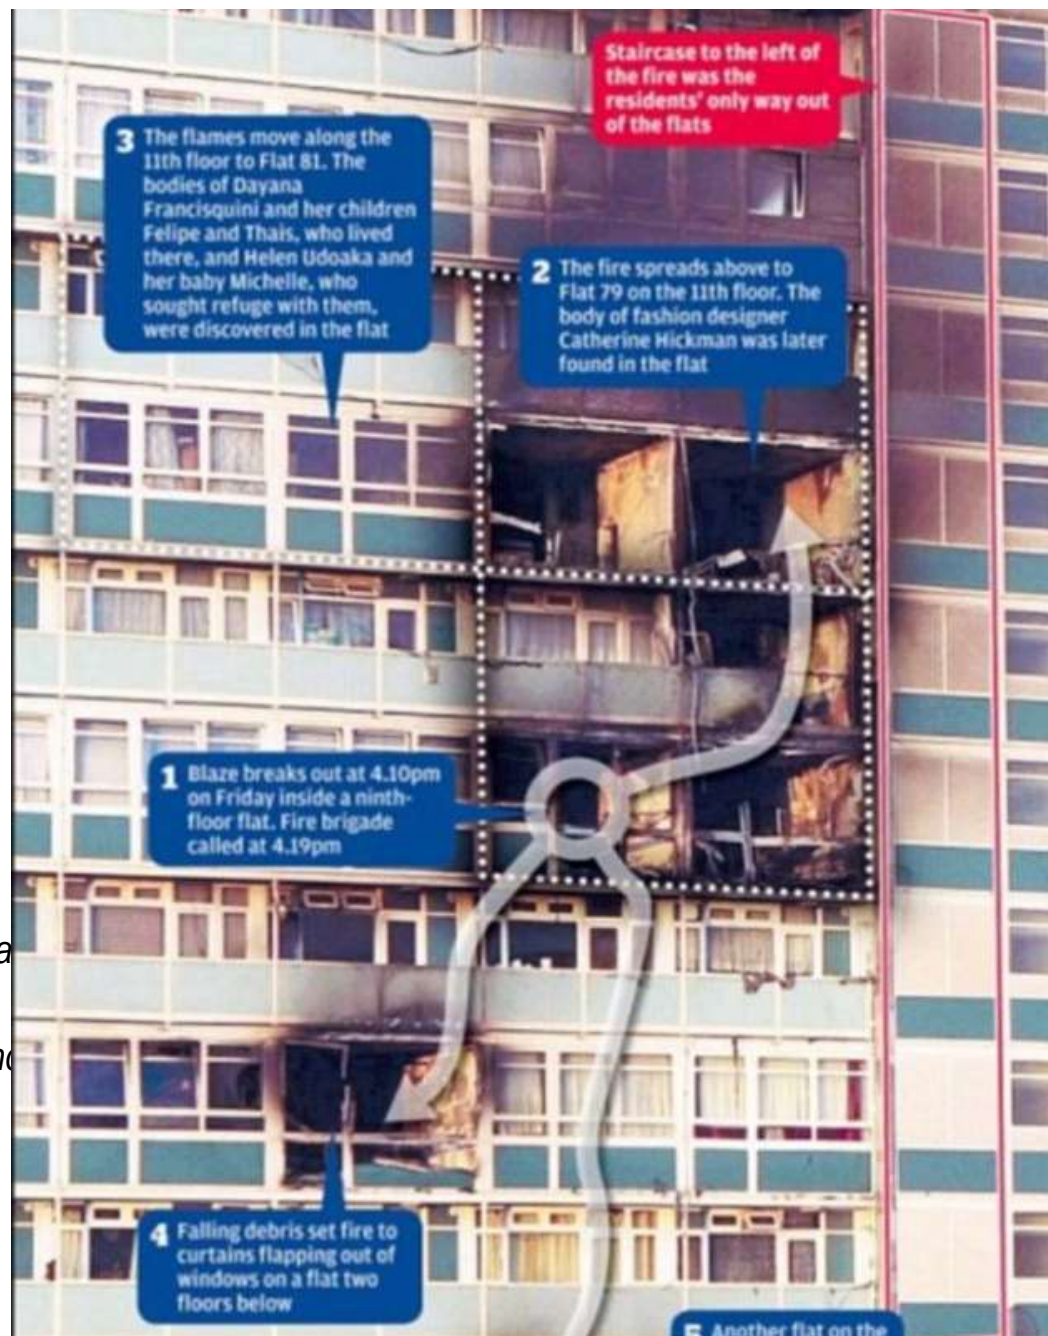
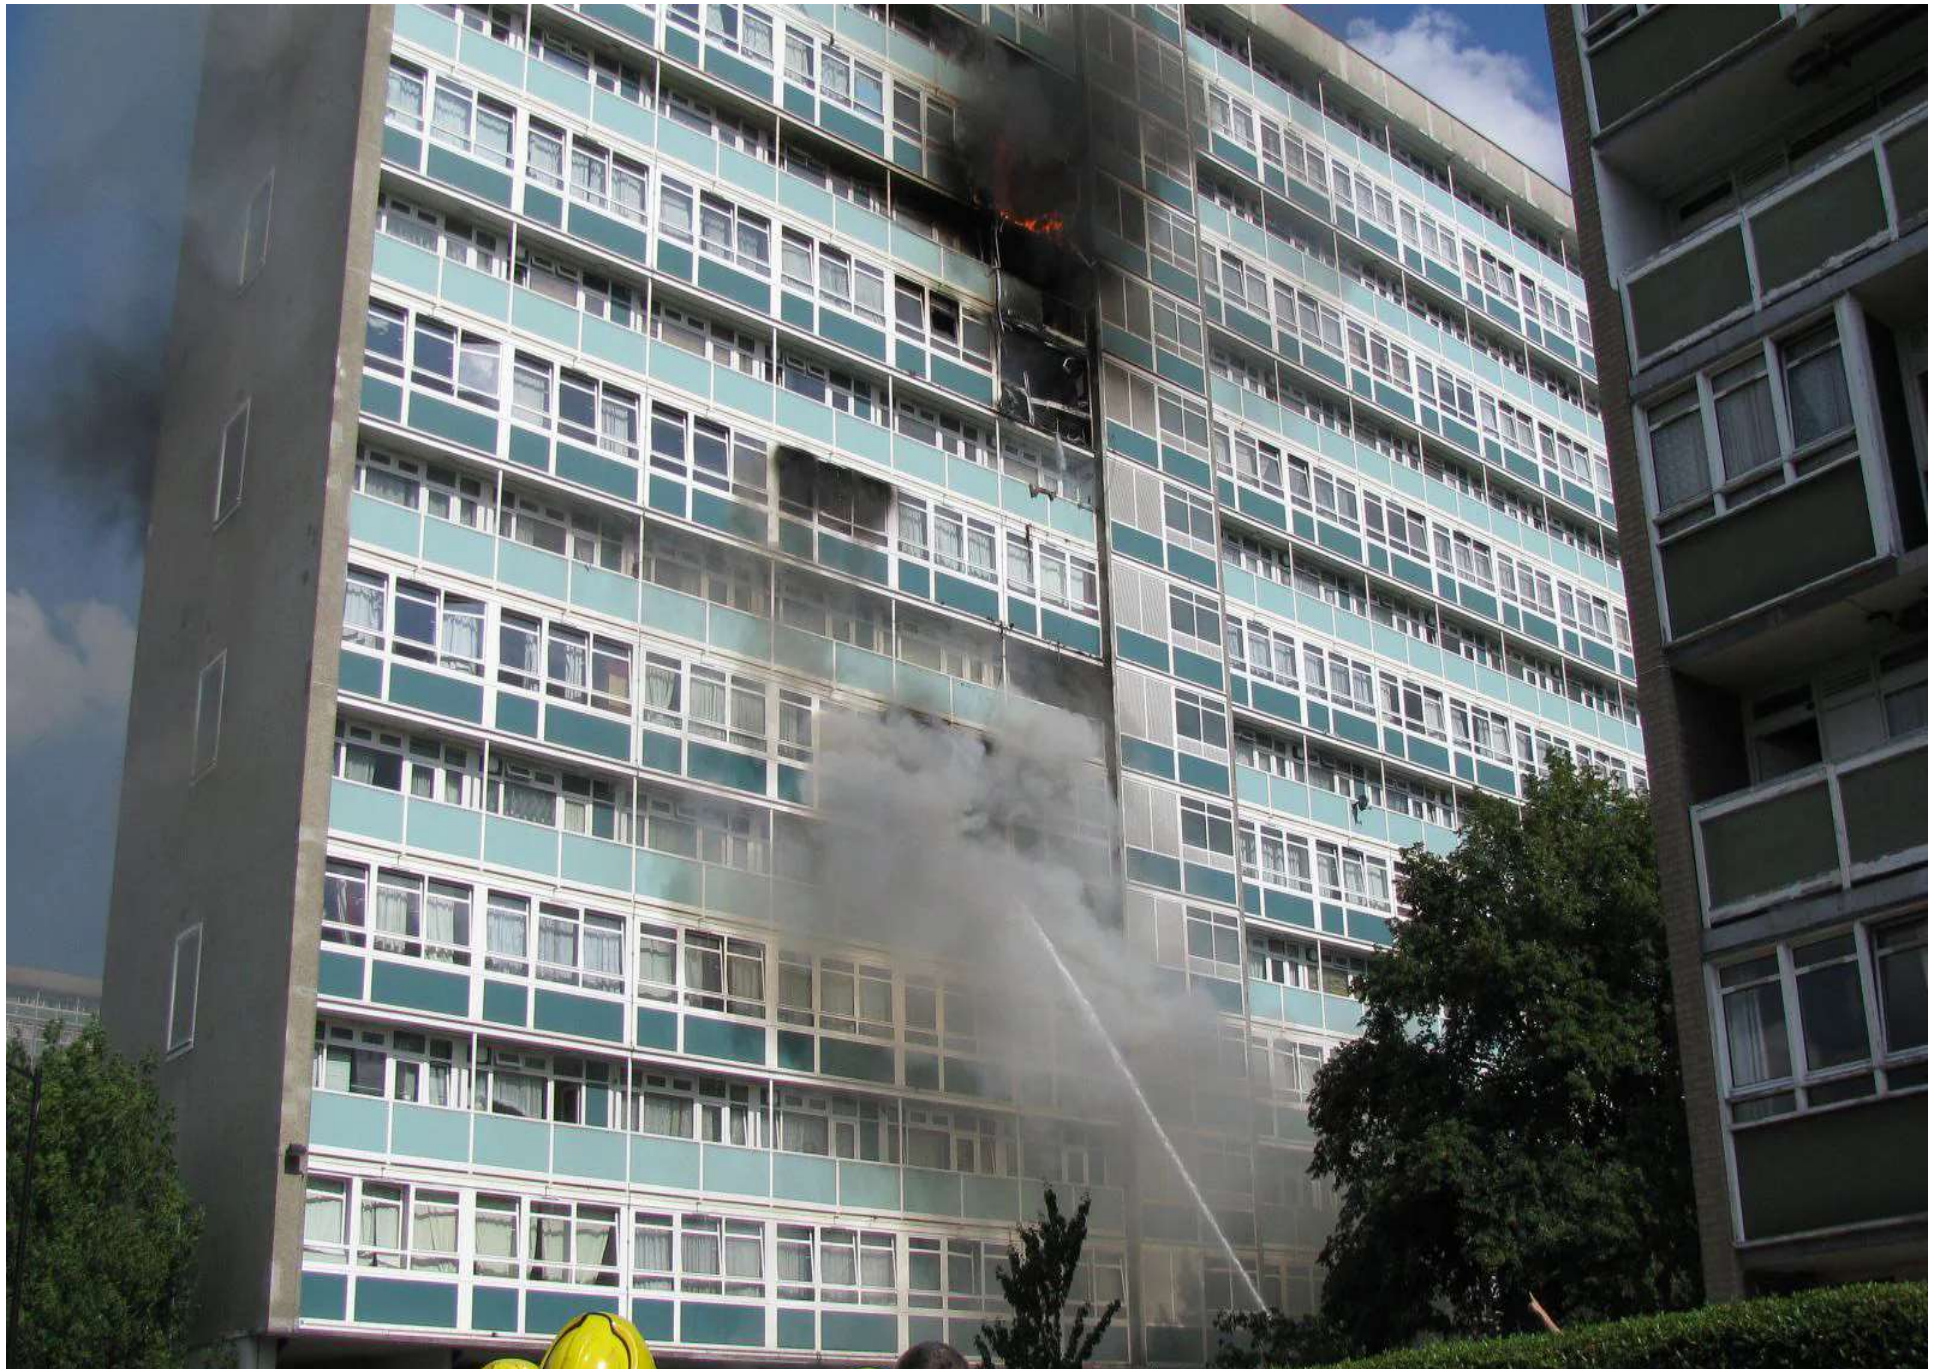
# Lakanal House:

- 6 Dead (3 children)
- Passive fire protection corrupted by installation of HW system in 2006
- £570,000 Fine for Council

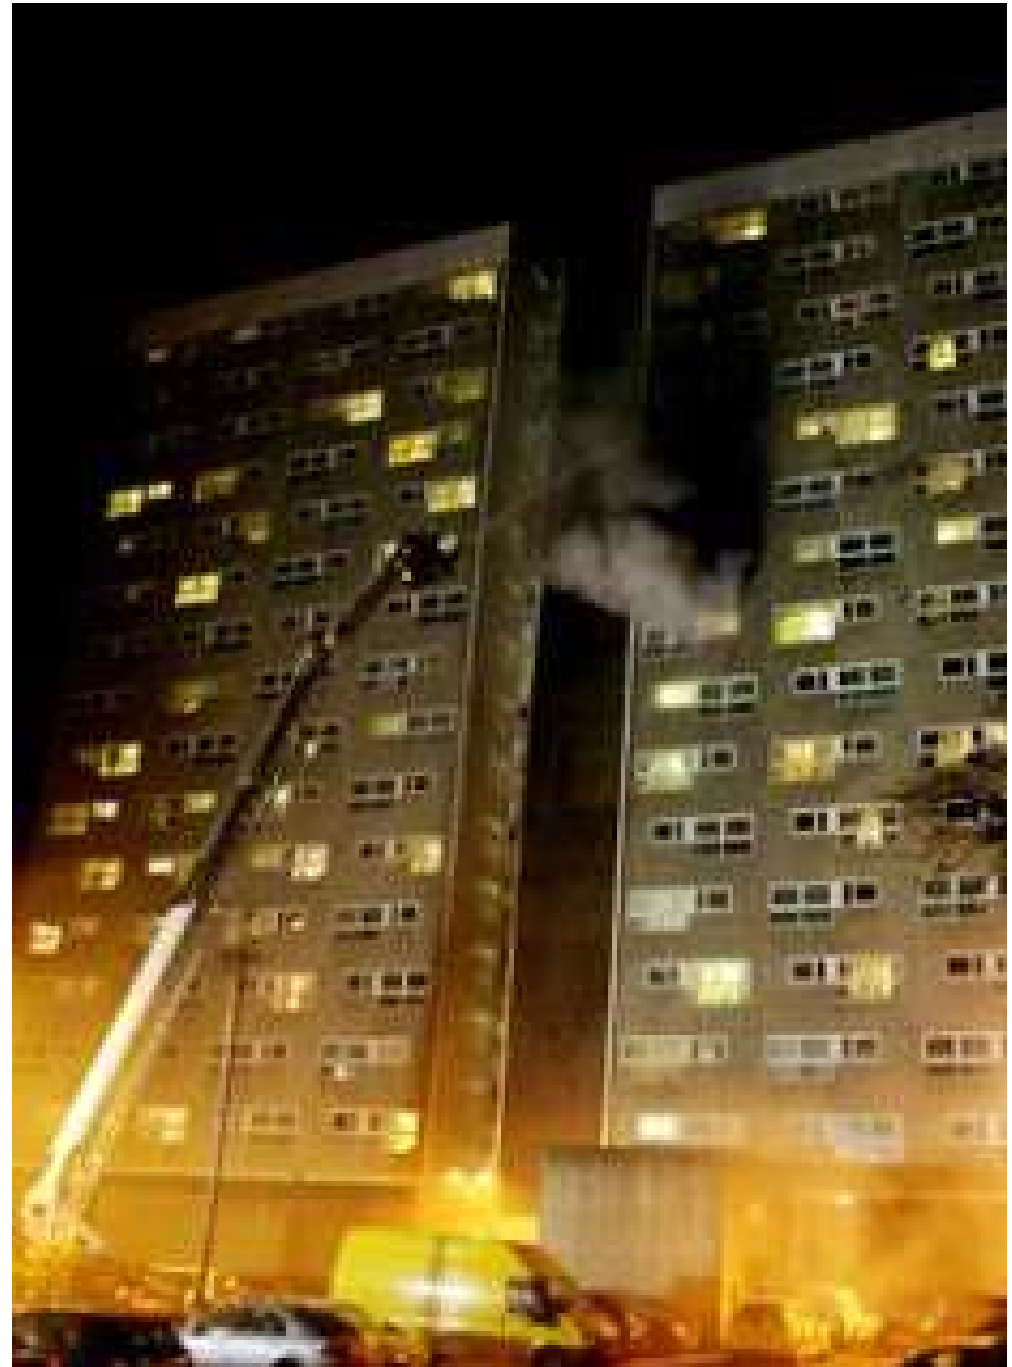
# Shirley Towers

2 fire-fighters died

Poor operational procedures as fire-fighters got above a developing fire

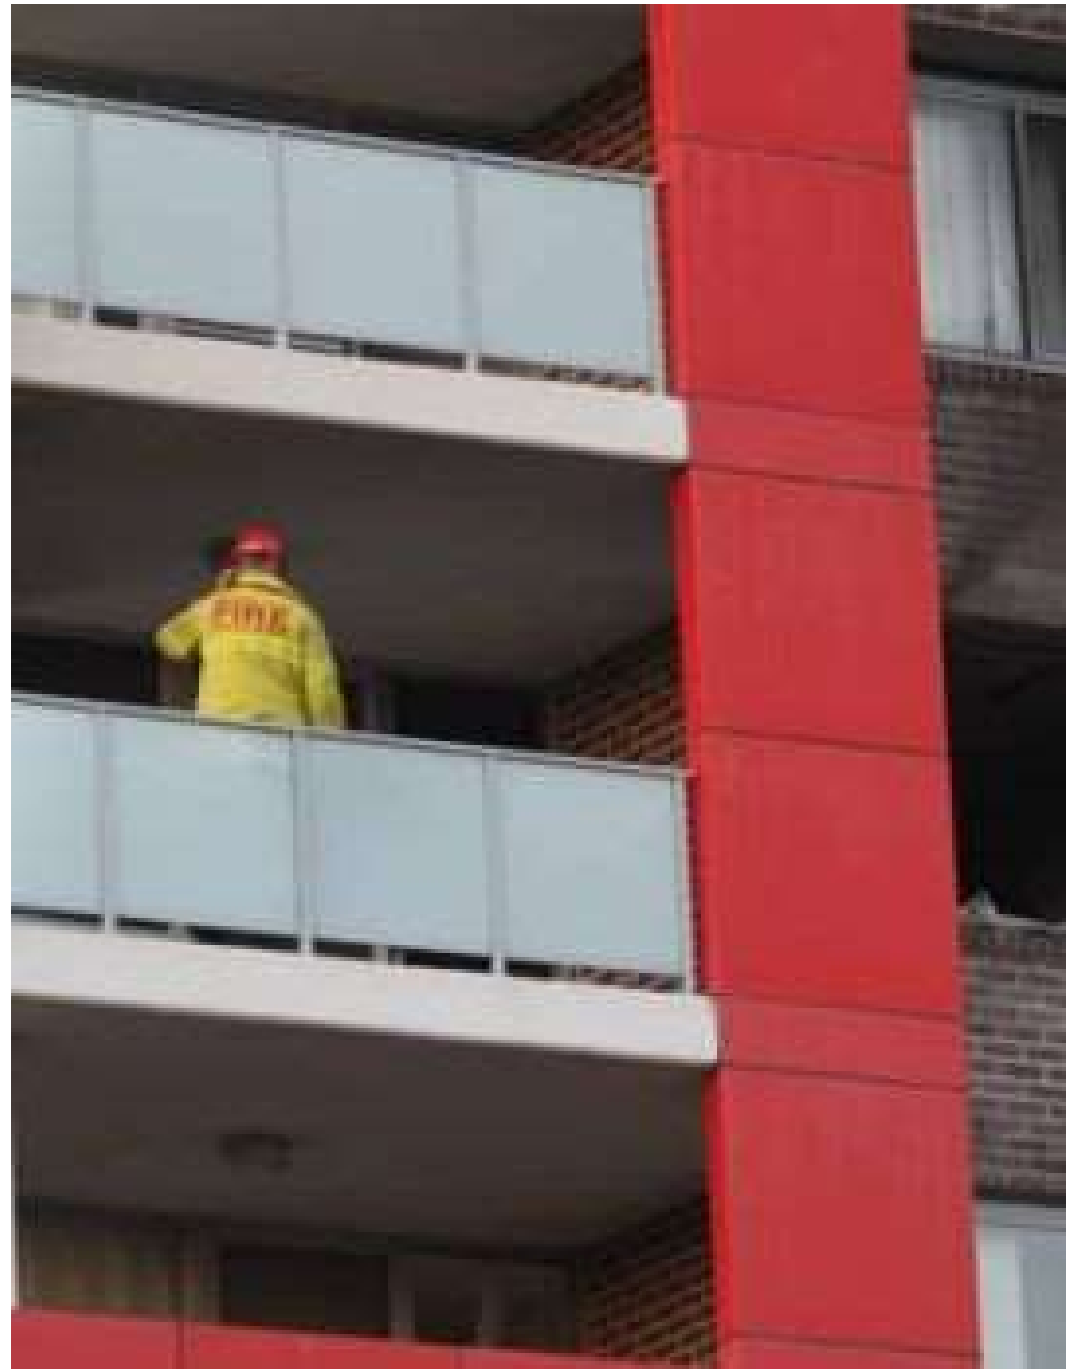
# Bankstown

2 people jumped from 5<sup>th</sup> floor apartment  
1 died and 1 is a paraplegic  
52 rescued by FRNSW

Coroner concludes apartment buildings  
under 25 m should be sprinklered  
FRNSW and CSIRO investigating  
sprinkler systems run from domestic  
plumbing or hydrant

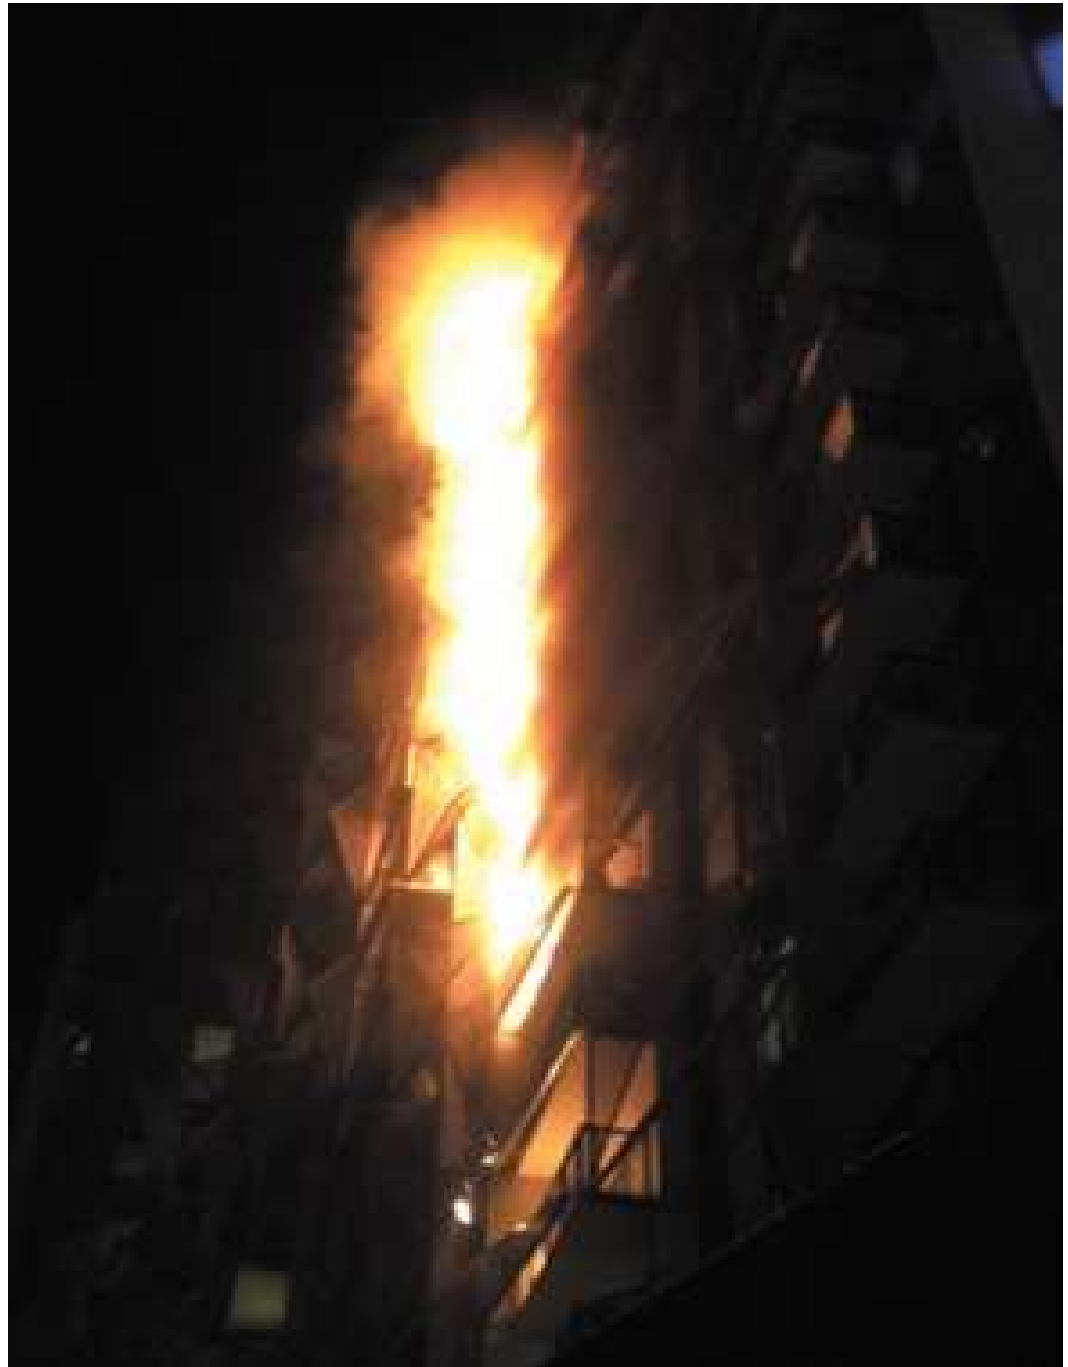
## Docklands

- No fatalities
- 23 levels, 400+ residents
- Fire started on 8<sup>th</sup> floor on balcony
- 26 heads operated

In the Docklands fire, the ABCB have decided to have sprinklers installed on balconies. This is a reversal of a previous position.

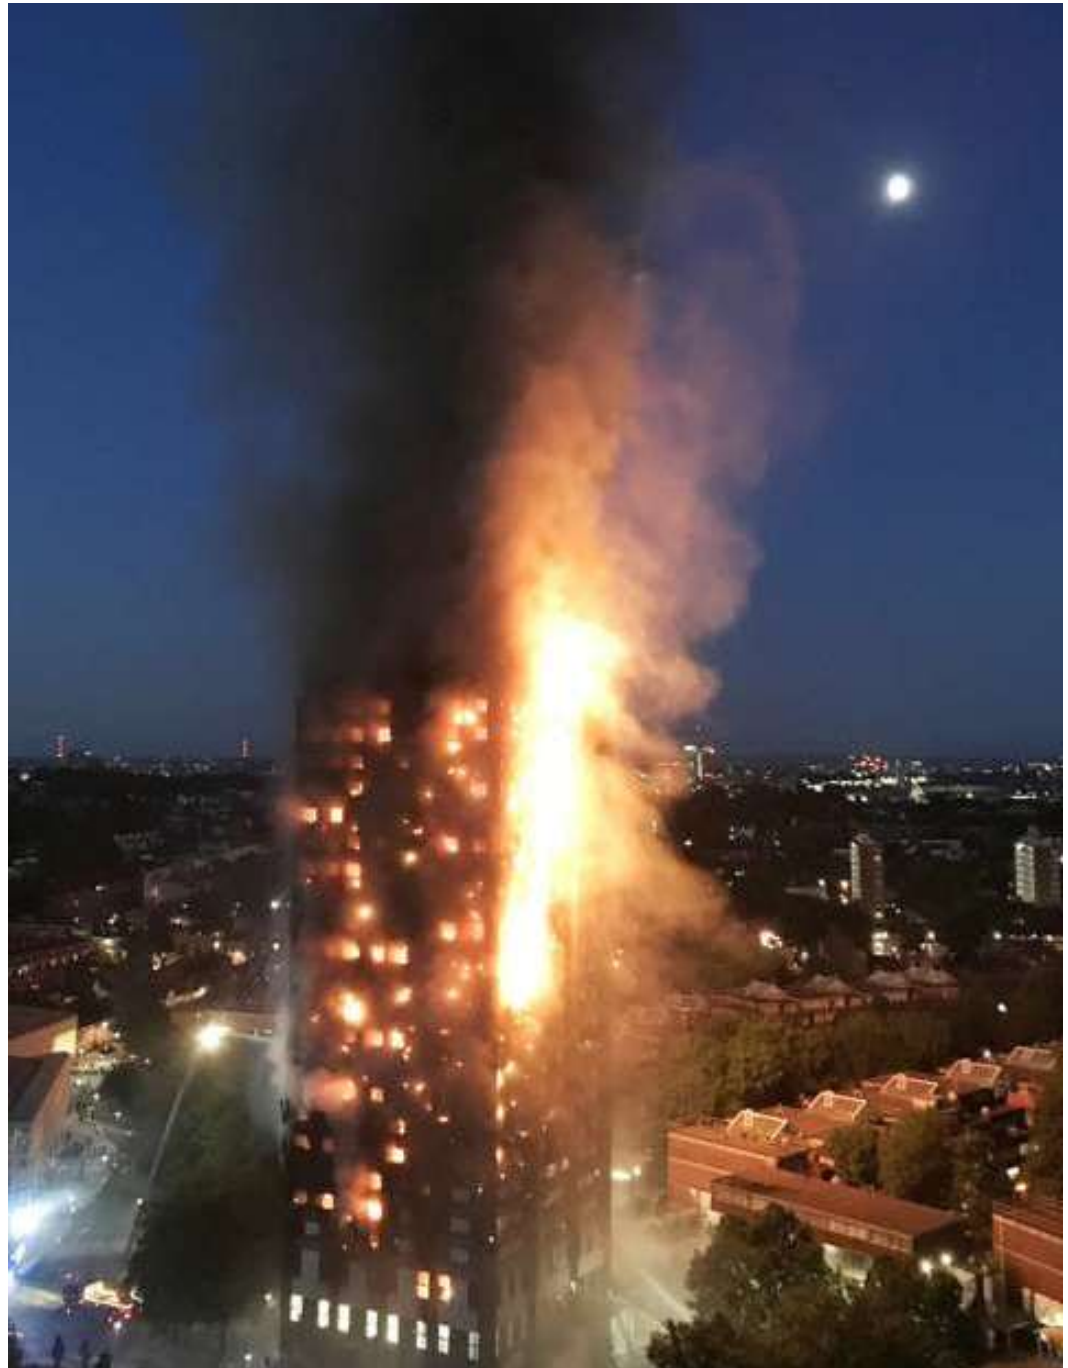
# Grenfell Tower: London 2017

80+ deaths

Suggestions as to cause of Grenfell Tower include a leaking refrigerator and that fire-fighters pushed the fire externally and set fire to the cladding

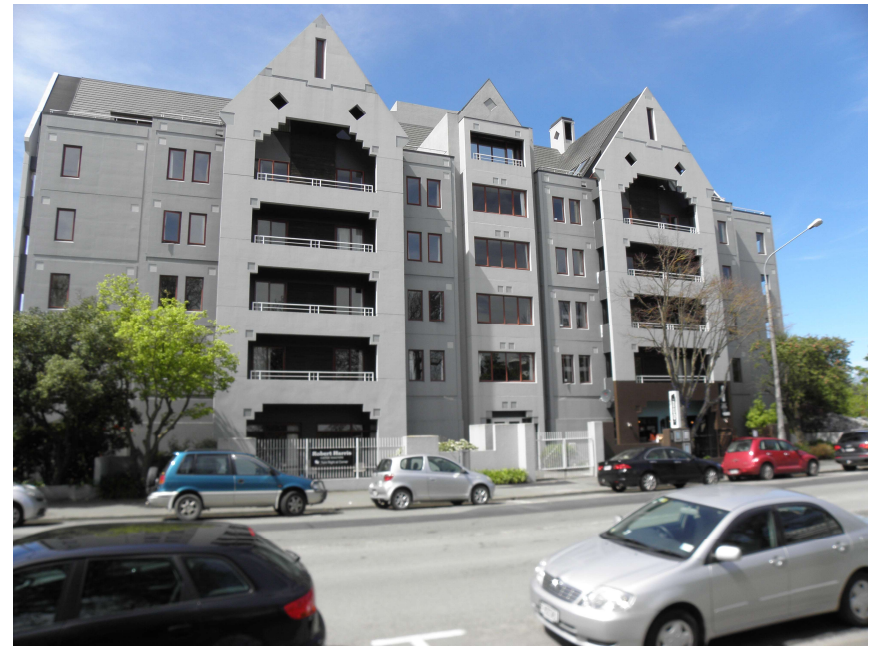
# Christchurch YMCA Fire

- Ground-floor café and facilities (gym, etc.)
- Level 1 to 5 bedrooms
- Building sprinklered
- Concrete floor slab

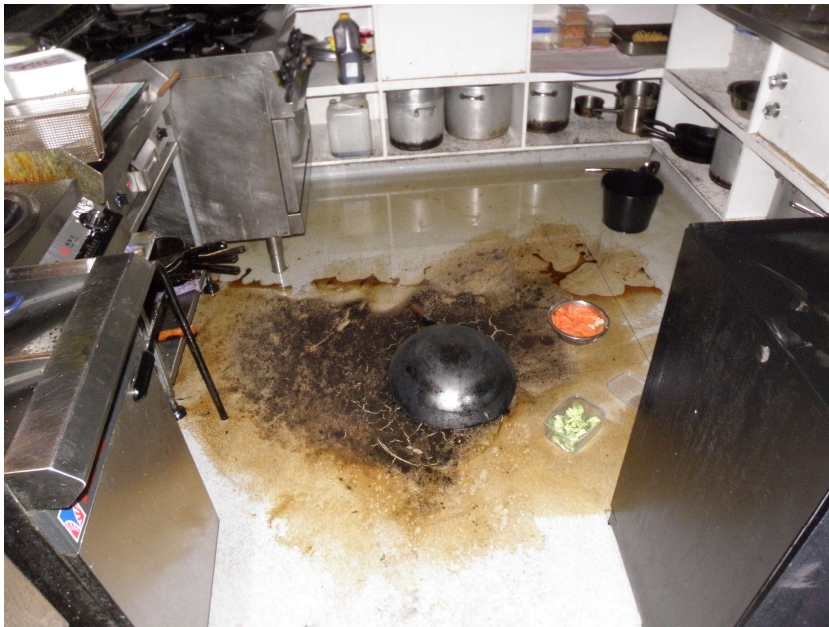
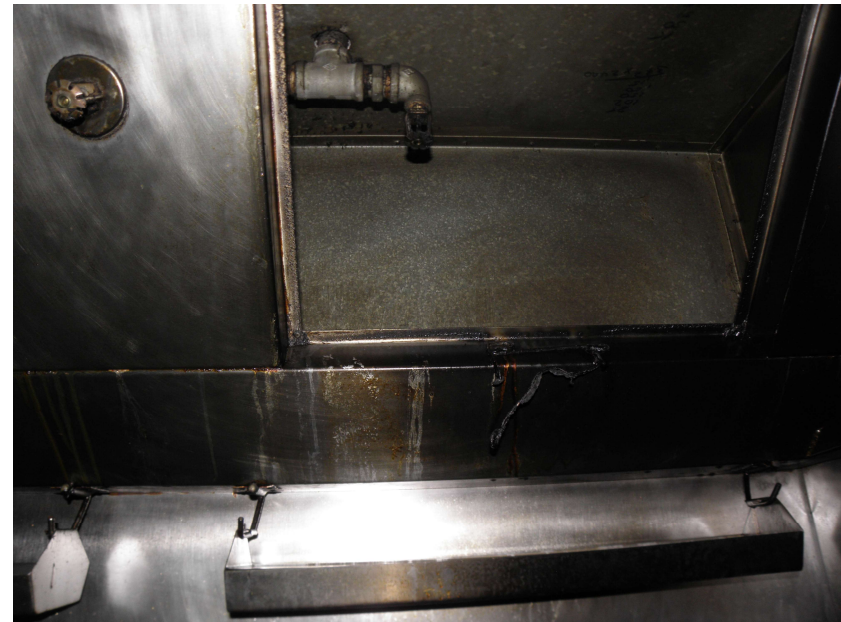
# Cause of Fire

- Fire started in ground-floor café kitchen
- No sprinkler activation in kitchen

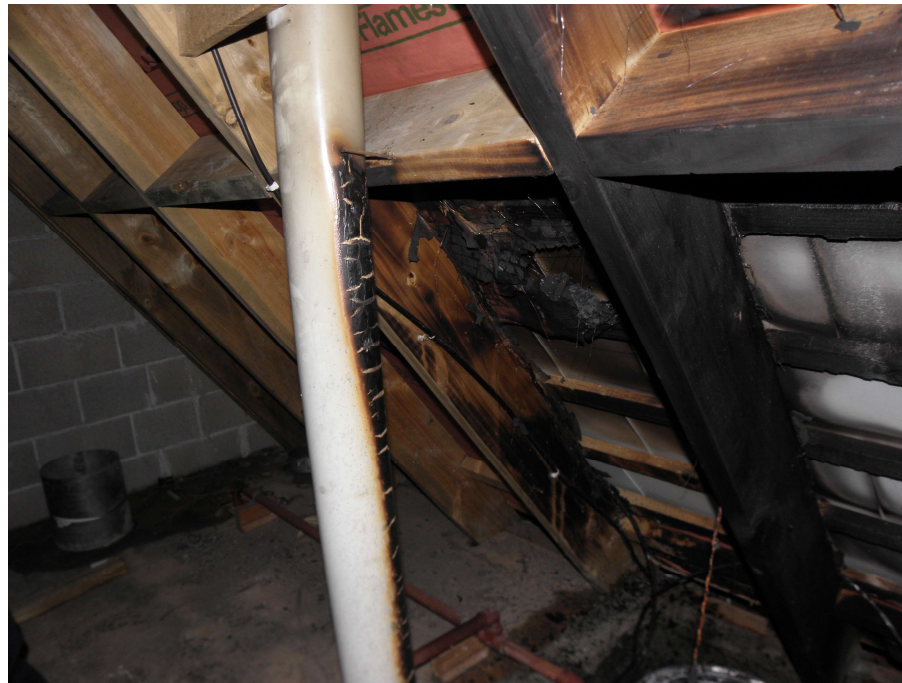
# Why the PIA?

- However, sprinklers in roof cavity activated - five levels above the known point of origin!

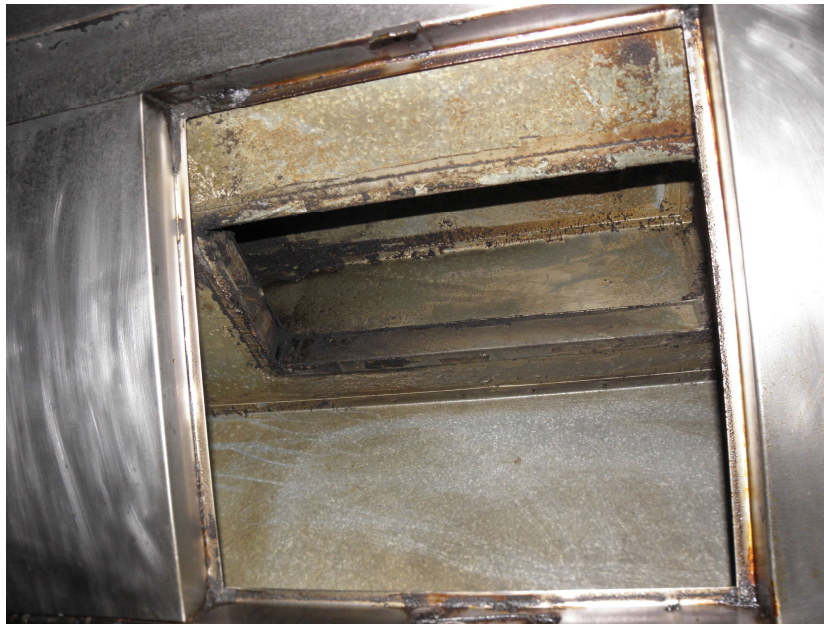
# Fire Spread

- Lack of sprinkler activation in kitchen
- Very light soot deposit in extract duct  
→ the fire travelled up quickly

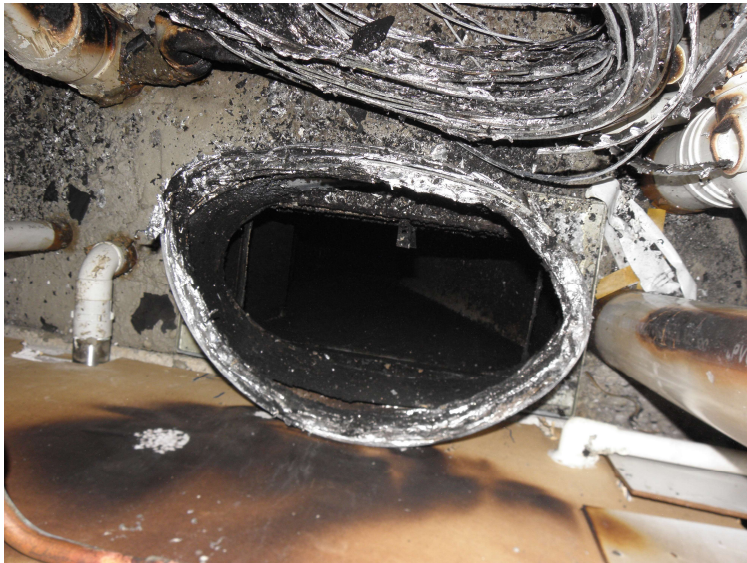
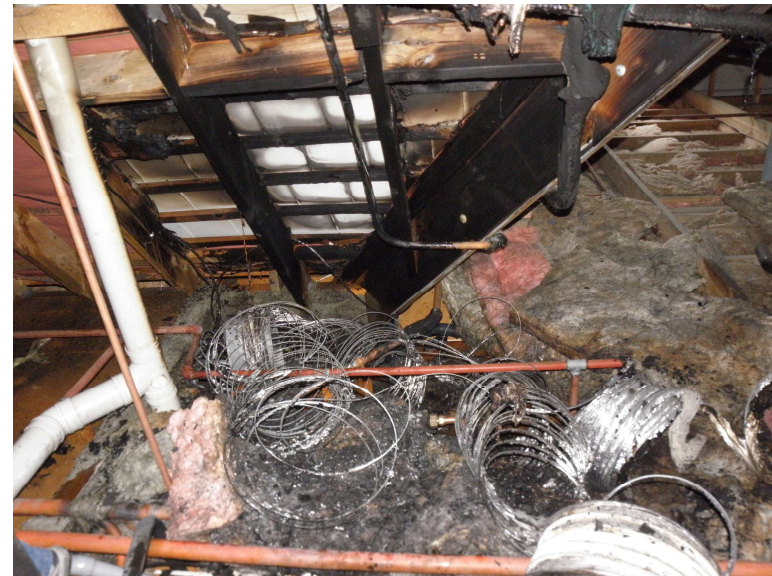
# Fire Spread

- No dampers in kitchen extract – typical
- Levels 4 and 5 ductwork was 'Flexiduct'
- Traps grease deposits
- Unable to contain the fire

- Never use flexible ducts in kitchen extract
- Designers should specify which fire stopping option is to be used for each riser
- Consider dedicated kitchen risers
- Consider servicing requirements for risers (e.g. 'hot' and 'cold' risers)

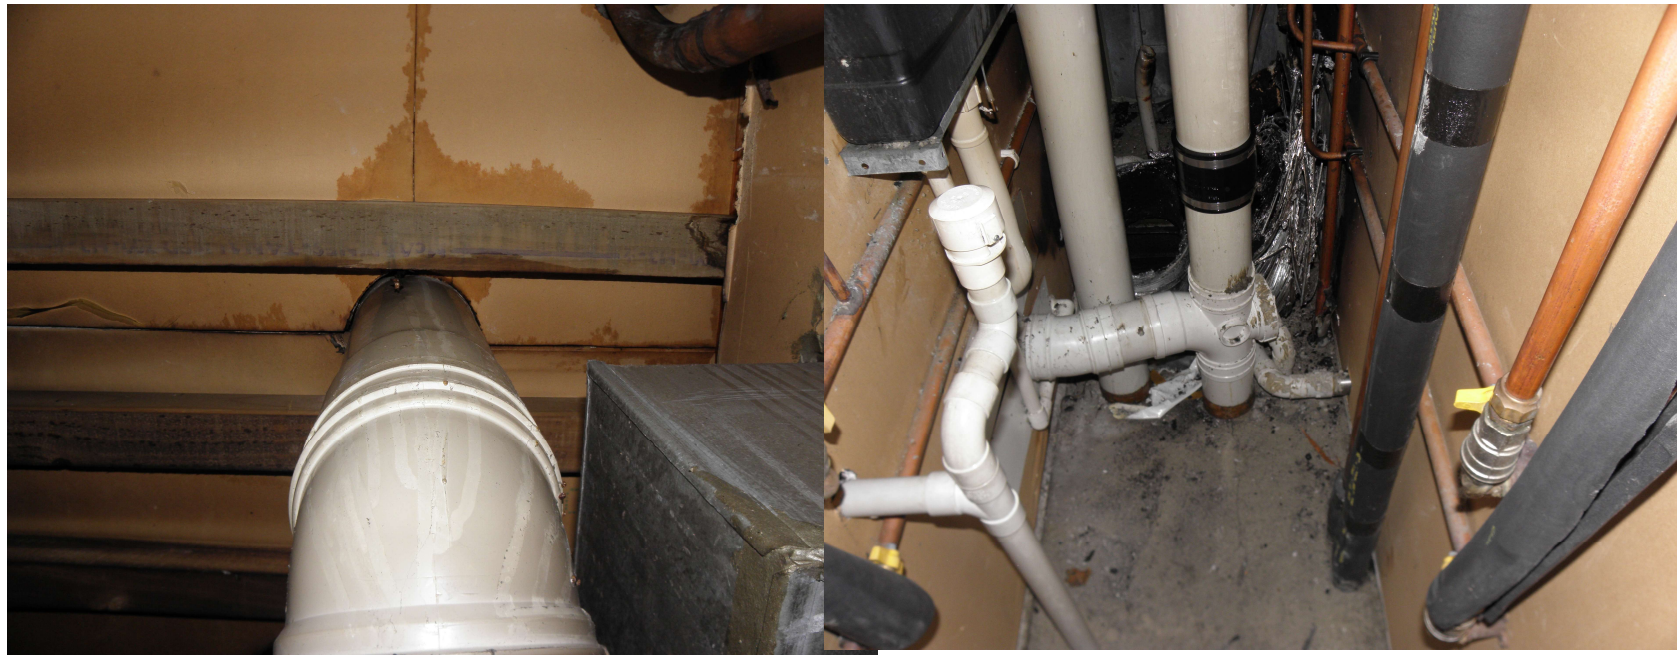
# Riser Issues

- Not only kitchen extract duct in riser
  - HVAC, Water, Sewage, Electrical, Comms
- Lack of effective fire stopping
- Poor riser layout makes servicing impossible

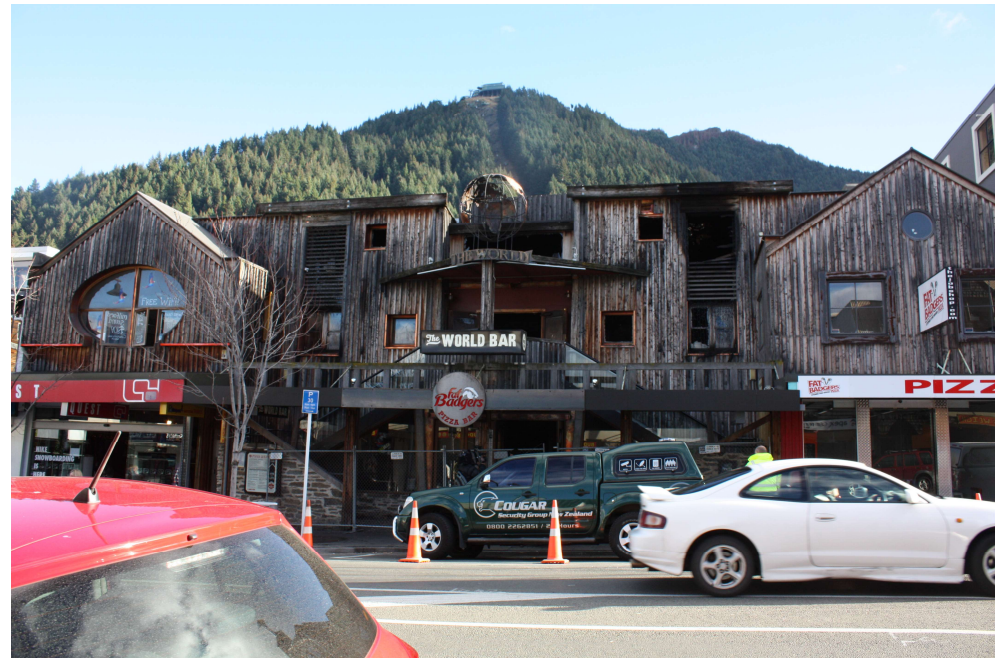
# Fat Badgers Pizzeria

- Two level plus mezzanine floor
- Bar and restaurant
- Two firecells
- Automatic alarm

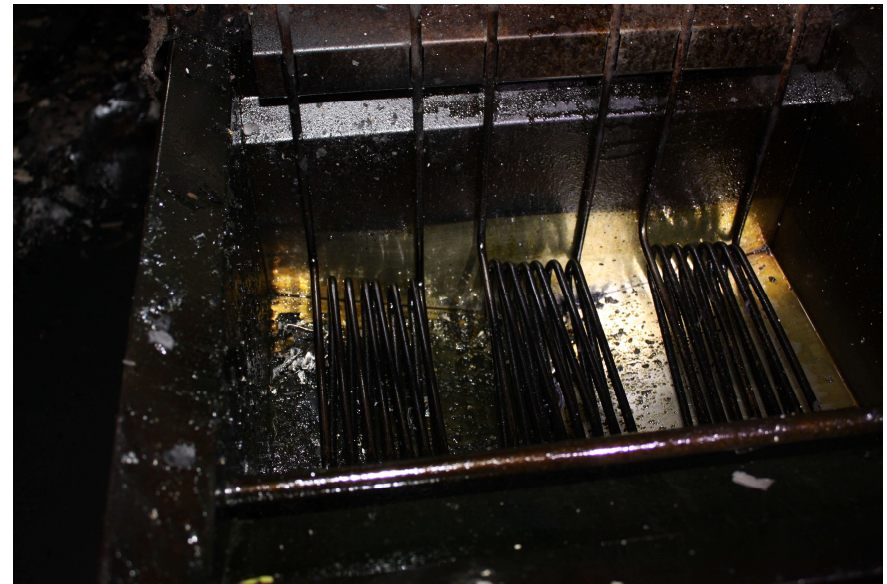
# Cause of Fire

- Fire started in deep-fat fryer in Pizza restaurant
- Oil level below level of thermostat
- Loss of temperature control of fryer unit

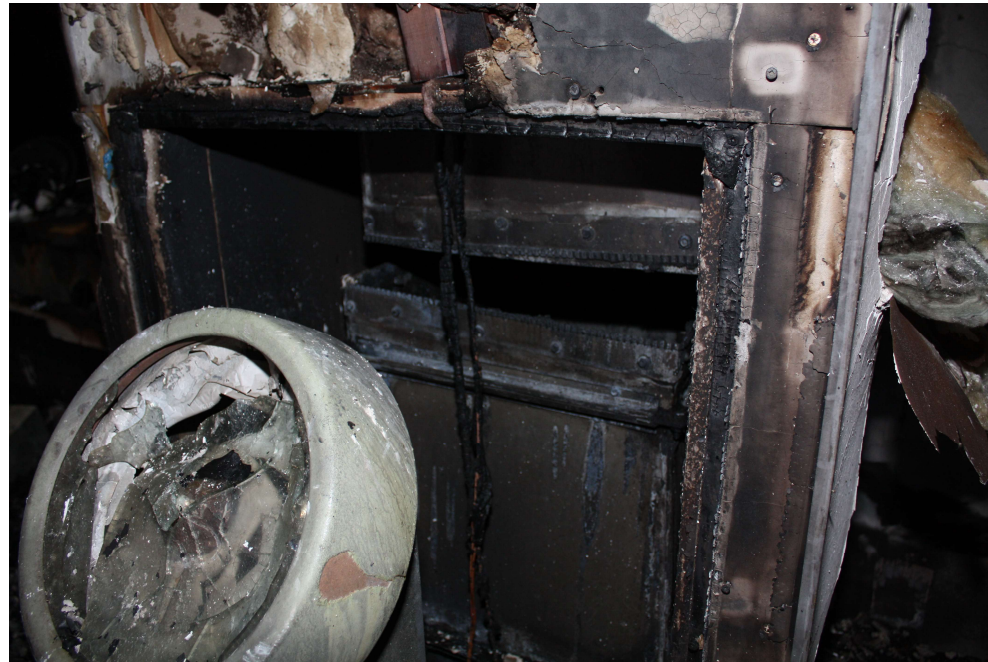
# Development of Fire

- Kitchen extract included an expansion/  
vibration joint allowed fire to spread into the  
riser

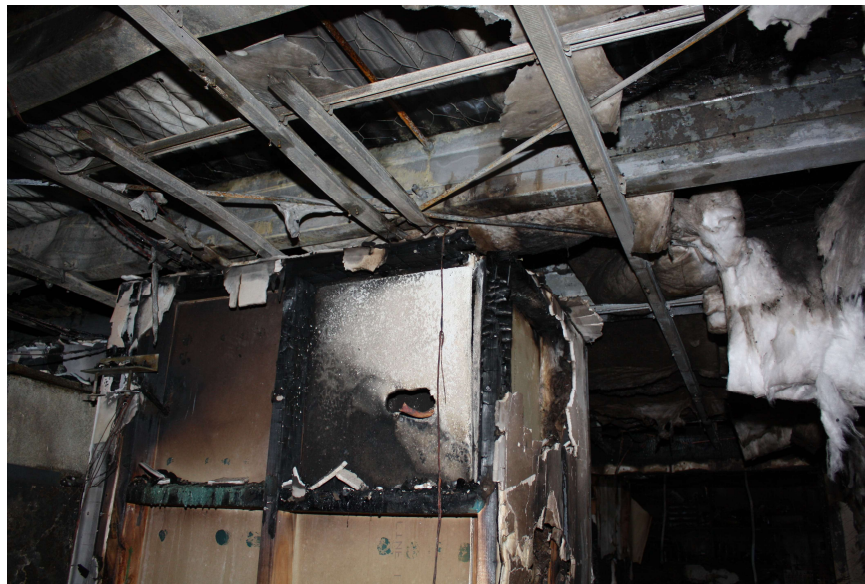
# Development of Fire

- Penetrations through wall allowed fire to spread into the upper level bar
- Residue in ductwork?

- Lack of effective fire stopping contributed to fire spread
- Effectiveness of sprinklers at mitigating damage
- Sprinklers are usually effective – with risks for which they are designed
- Circumstances change – can affect fire and failure scenarios
- Critical assessment at each inspection
- No substitute for checking!

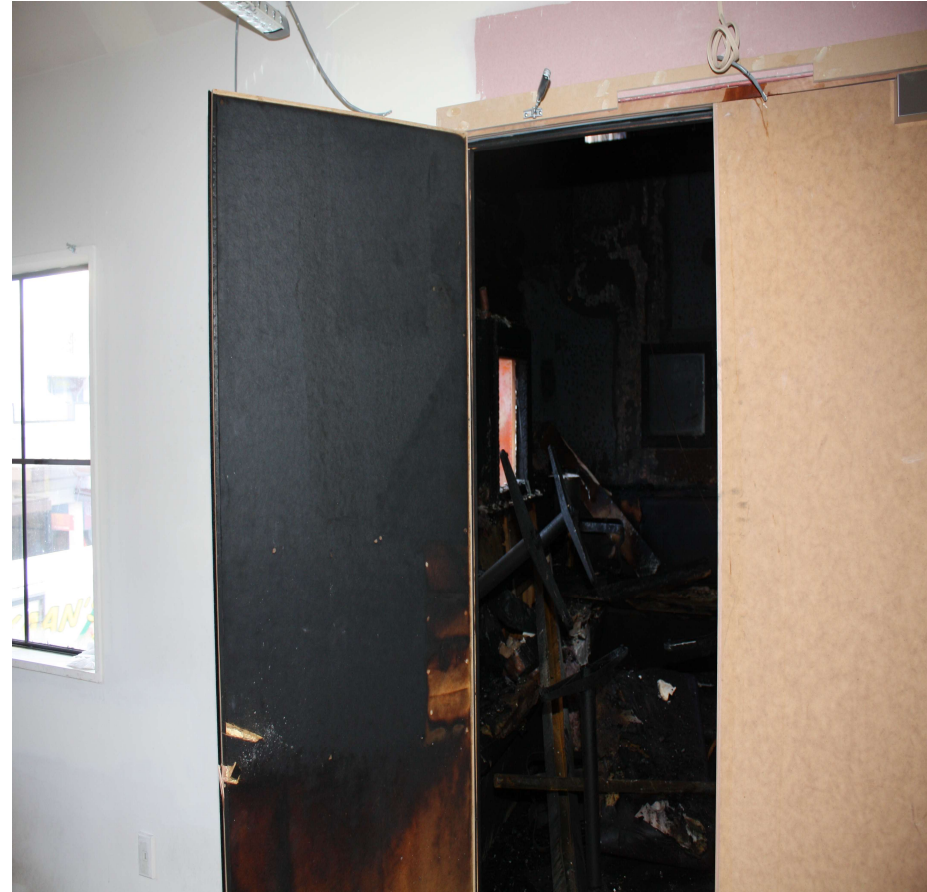
# Design Issues

- Effective fire separations provide significant benefit – new construction
- Failure of fire separations resulted in the damage to the World Bar
