Compliance– Its not Black or White

Warwick Isemonger

Compliance Officer
FRNSW

Grenfell Tower – compliance nightmare

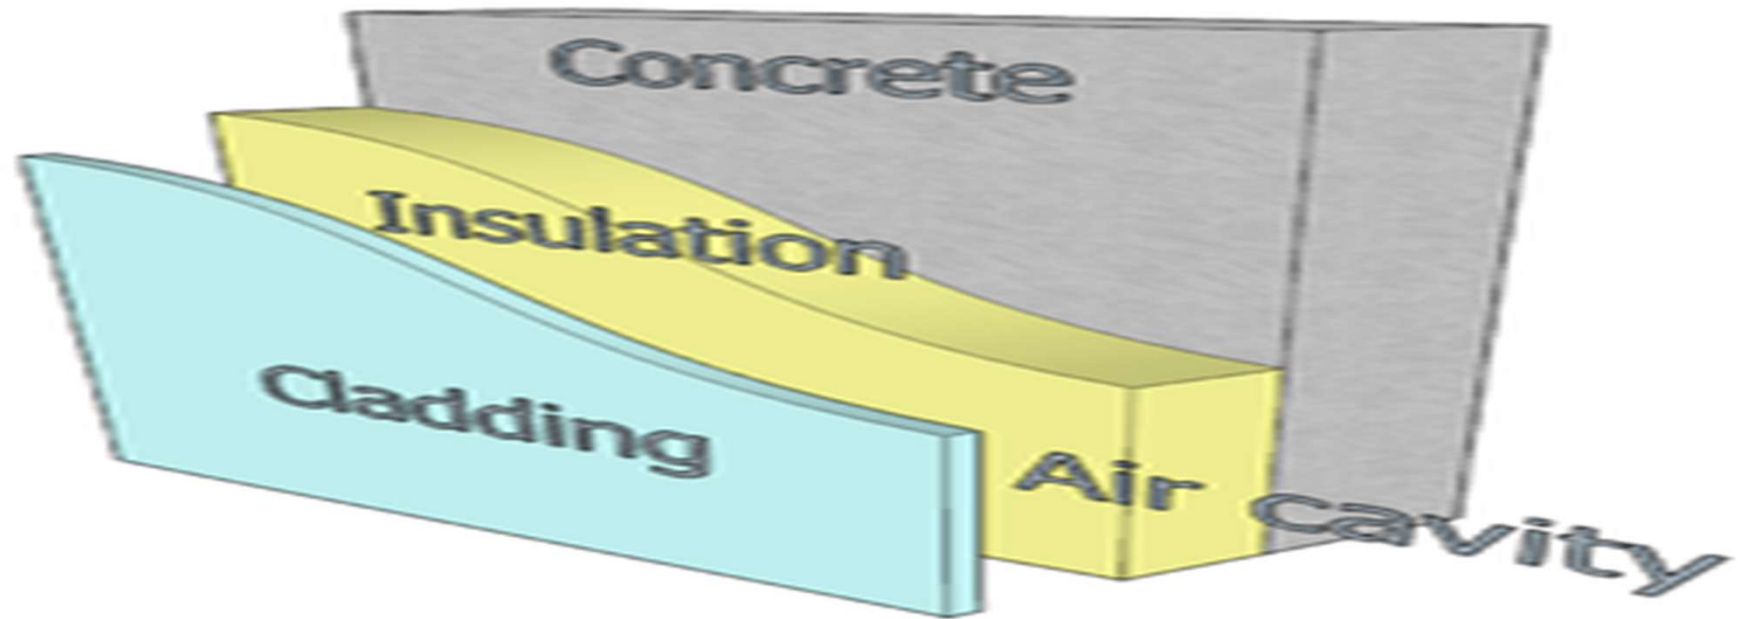
The Cladding

The structure consists of 3 mm cladding (Reynobond PE), 50 mm ventilated cavity, 150 mm insulation (Celotex RS5000) and 250 mm existing concrete

- ▶ As part of the project, in 2015–2016, the concrete structure received new windows and new aluminium composite rainscreen cladding, in part to improve the appearance of the building.
- ▶ Two types were used: Arconic's Reynobond PE, which consists of two coil-coated aluminium sheets that are fusion bonded to both sides of a polyethylene core; and Reynolux aluminium sheets. Beneath these, and fixed to the outside of the walls of the flats was Celotex RS 5000 PIR thermal insulation.¹

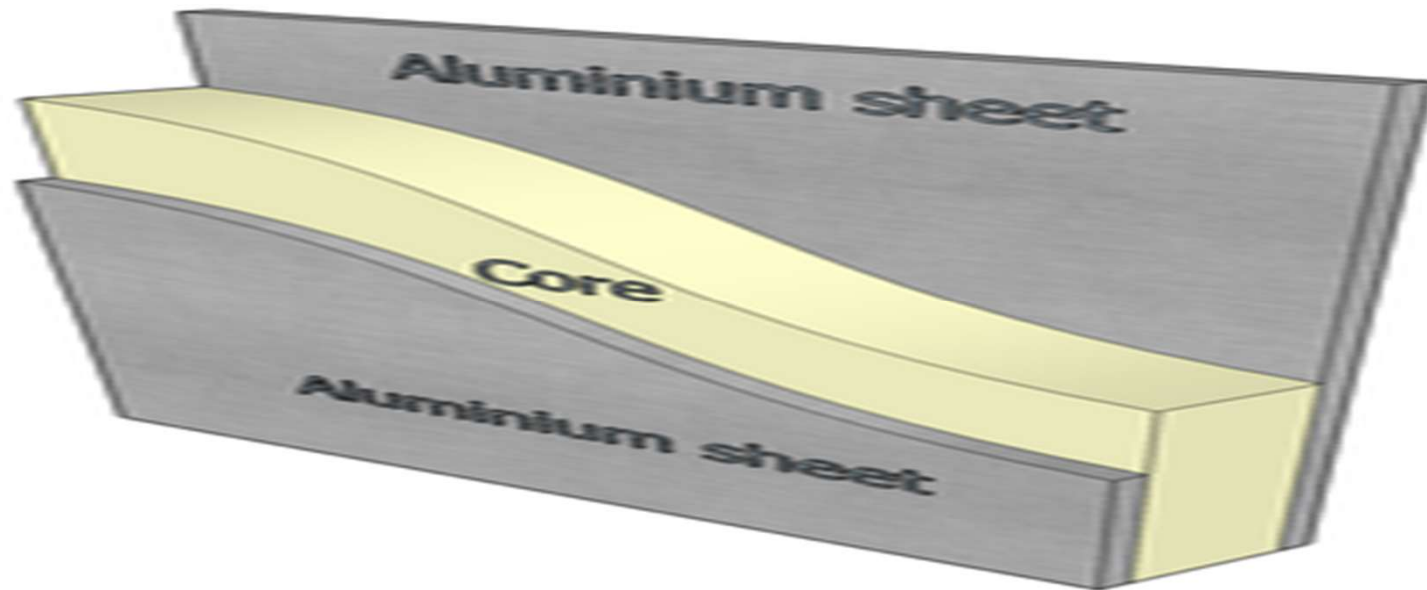
The Cladding

Structure of an ACM sandwich panel. In the case of Reynobond PE, aluminum sheets' thickness is 0.5 mm (0.020 in) and overall panel thickness is either 3, 4, or 6 mm. Fire safety experts have said that the building's new external cladding was a possible cause of the rapid spread of the fire. Experts said the gap between the cladding and the insulation worked like a chimney to spread the fire

- ▶ Interestingly, external cladding has been around for many years and used successfully on many buildings in over 50 countries.
- ▶ Aluminium Polyethylene Cladding which includes products referred to as ACM (Aluminium Composite Material) or referred to as sandwich panels the combustibility of which is dependant on the insulation material used between the layers of Aluminium.
- ▶ One has a poethylene core (similar to polystyrene) and the other has a Fibre Mineral core(less flammable) with the latter about \$5 per meter more expensive.
